Summary Sheet - An Assessment of Sand Dam Function

2017 Mennonite Central Committee Kenya, Utooni Development Organization, & Sahelian Solutions Foundation

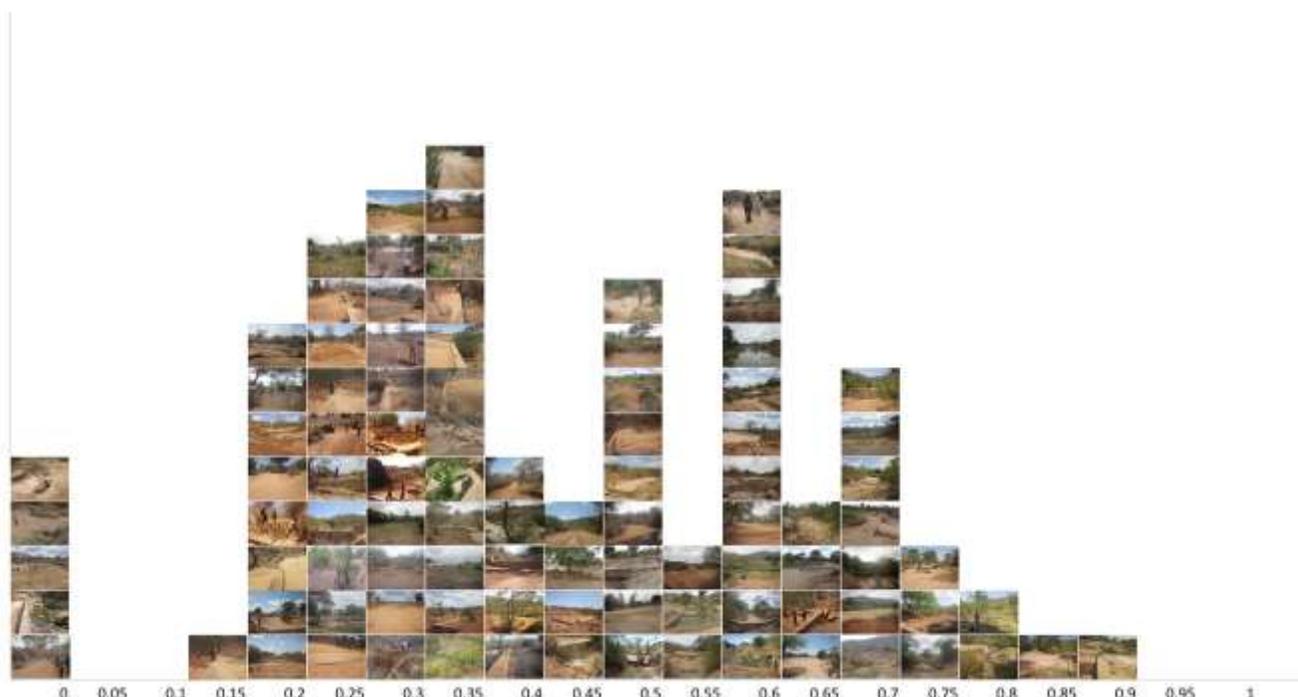
Figure 1. Pictures of the 97 surveyed dams, arranged based on their integrated rating of functionality. The five dams at "0" were completely broken and therefore nonfunctional. Dams closer to the "1" value were deemed the most functional. Note that most dams are distributed in the intermediate values.

We found that most dams would not be considered either “optimal” (ample water throughout the year and robust usage by the community) or “failures” (little capacity for water storage and/or largely unused). Most dams fall in the center of the rating, showing some clear evidence of use, but also showing some lack of water and/or lack of use by the community.

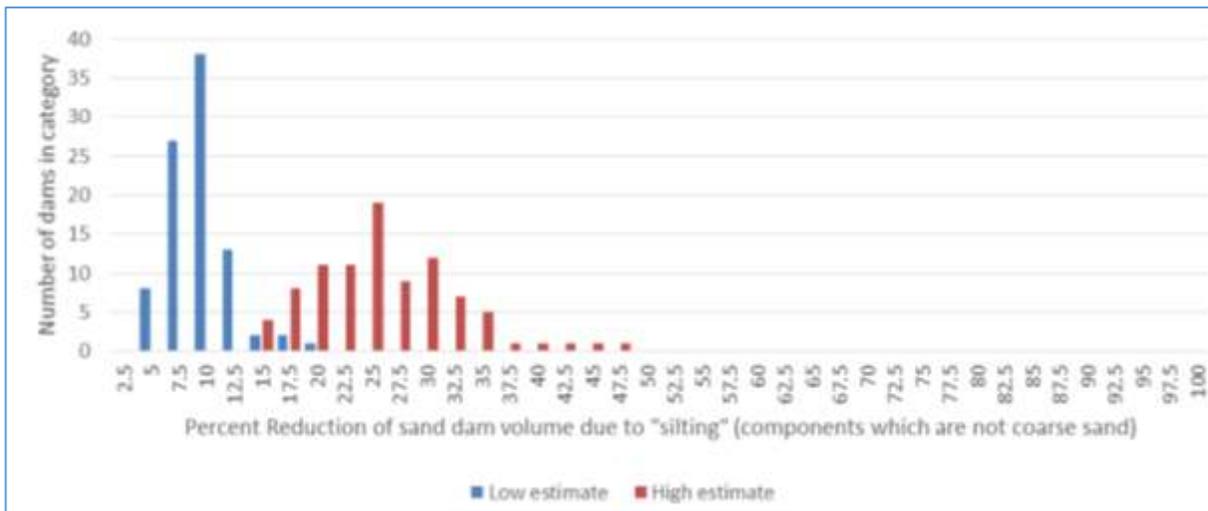
Figure 2. The effect of siltation on the volume of water held in sand dams was calculated, using two boundary estimates for how much water is held by sand, silt and clay. The average reduction of water volume due to siltation was 10 to 25% (depending on how it is estimated).

Questions about the degree of siltation at sand dams have been rightly raised in recent years, as practitioners seek to continually improve sand dam function. We found that while having some effect on reducing water volume, siltation did not severely limit the potential storage capacity in most dams. In broad terms, silt buildup is not the primary constraint to sand dam function.

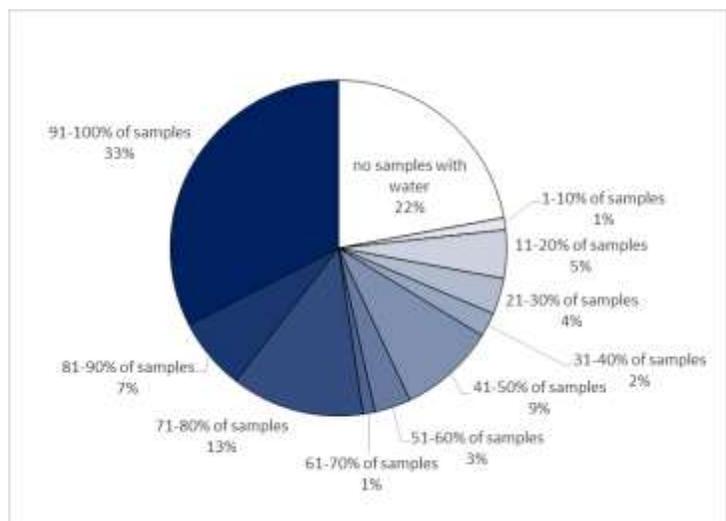
Figure 3. Percent of dams that have moisture in different proportions of samples taken at that dam. The darkest blue wedge, for instance, is the percent of all dams surveyed that had moisture in 91 to 100% of the sand samples taken from that dam.

Most (78%) of dams had moisture in the sand from at least some samples, with most dams having moisture in more than half of their samples. The presence of moisture suggests most sand dams are holding water. Deep coring (on average, our cores were 0.7 m deep) would presumably increase the percentage showing water even more. Extractable water is likely present in most dams, although a smaller fraction of dams are actually being used for water harvesting.

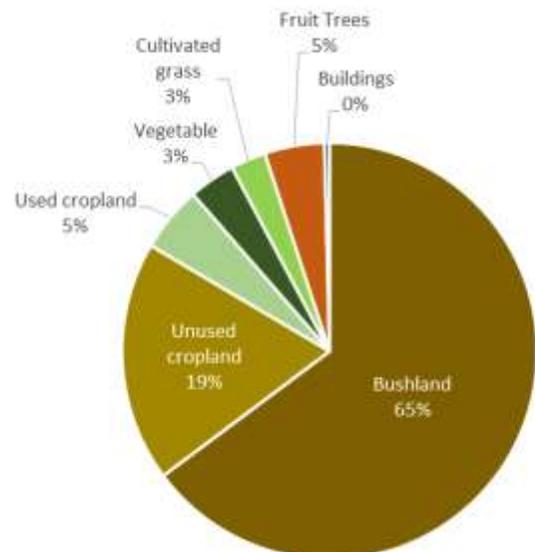
Figure 5. Land use adjacent to sand dams, expressed as average percent land used for various activities.

Land use was assessed in transects to an estimated 30 m laterally from the dams, at 15-50m intervals (depending on the size of the dam), as a means of quantifying agricultural uses of the land near dams. Most land adjacent to dams was bushland (including scrub trees,

pastureland) and unused cropland (e.g. crops had obviously been grown in the past, but the land was currently unused) No active agricultural activities adjacent to dams were observed in 61% of dams surveyed, during the dry season when surveys occurred. In the 39% of dams with agricultural activities, most of these had multiple activities.

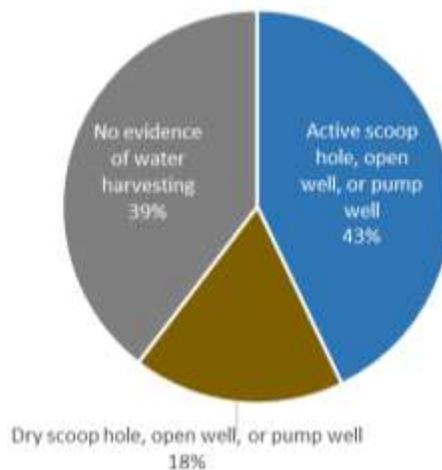
Figure 6 Percent of dams utilized for water harvesting.

In 39% of all dams, there was no evidence of attempts to extract water. Of the remaining dams (where there was evidence of water harvesting), two-thirds were currently extracting water, and the remaining had stopped water usage as sources had dried. Of dams where there was no evidence of water harvesting, 81% had evidence of water in the sand cores.

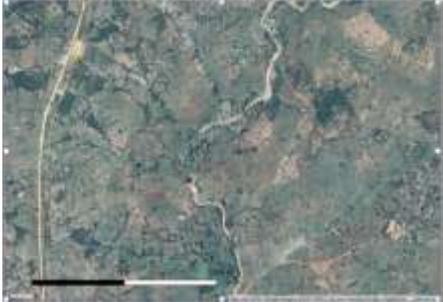
Satellite Image	NDVI, Jan-Mar dry season	NDVI, Aug-Oct dry season
<p>Makongwe, one of the more successful dams that was visited (red star is dam, orange star is drawback point). On the ground, there was obviously a great deal of vegetation around the dam.</p>

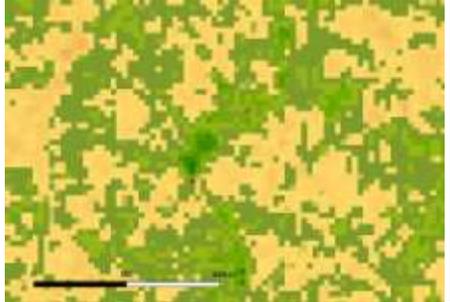
<p>The increased greenery is especially obvious in the October image. Of all dams visited, this was the most obvious NDVI evidence of greenery associated with sand dams.</p>

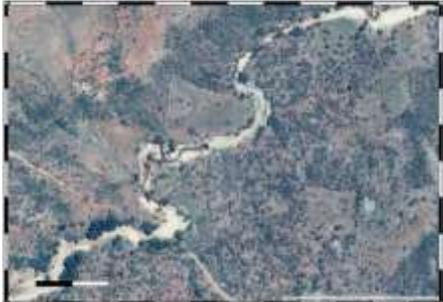
<p>Kyangiti, Kitui. Dam on a larger stream (which contains a good deal of sand throughout its channel).</p>

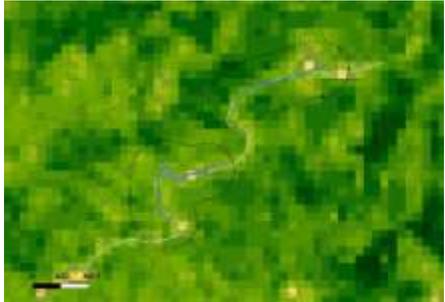
<p>The 100m buffer zone is shown here, for which NDVI was quantitatively analyzed.</p>

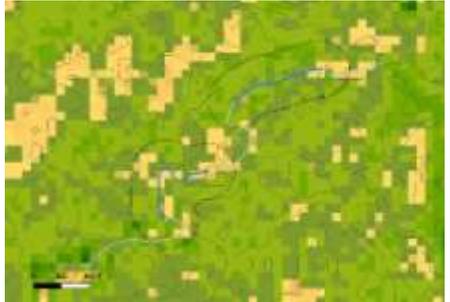
<p>A grove of trees upstream from the drawback shows higher greenery levels, but the sand dam area itself (bottom left buffer) is not obviously greener than other areas.</p>

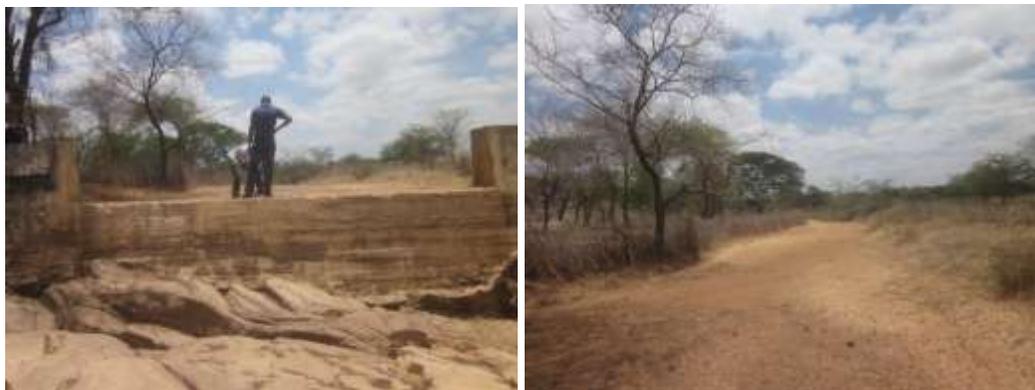
Dam #622, Munandani; surface has sand, but no evidence of usage late in the dry season.

Two dams were built at Munandani, in Makueni County, on tributaries of the Thwake River. Dam #622 was built in 2010 at the request of a group, which rapidly made good use of the water for a variety of activities such as a thriving tree nursery. When visited on August 27, 2016 (late in the dry season), this was no longer the case. The group had ceased collaborative activities at the dam, and there was no evidence of water harvesting, or of activities adjacent to the dam that were supported by water from the sand dam.

Why did use of the dam stop after a promising start? The structure was intact, albeit with notable erosion on the edges of the structure. The dam area was filled with medium and coarse sand – there was no indication that siltation was a problem. Water was found in half of cores from the dam, at depths of less than ½ meter. Satellite images show greening of vegetation along the waterway during the previous Jan-Feb dry season, albeit less than other nearby locations with sand dams. Thus in general, the dam itself seemed functional, and it seems likely that even in late dry season of Aug 27, 2016, that there would have been harvestable water deep in the sand.

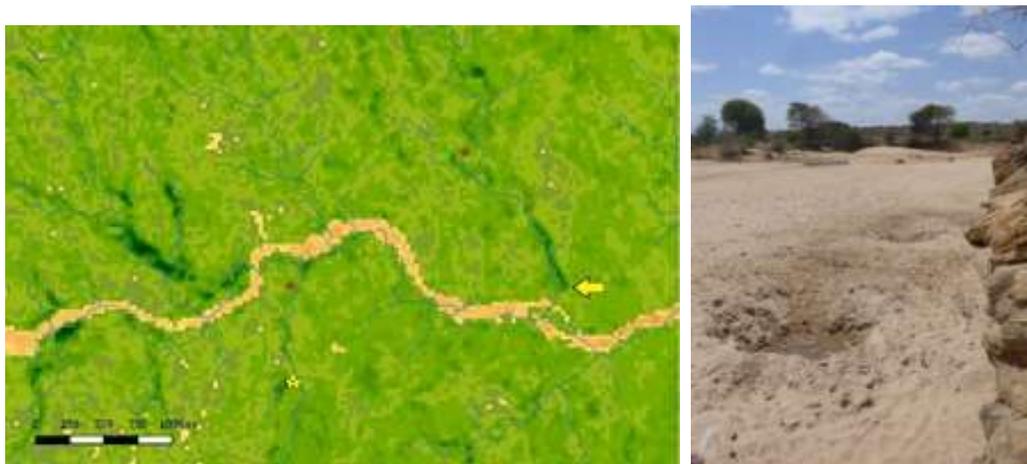
Satellite analysis showing greening along waterways, especially at several dams. Dam #622 is located at the yellow star, lower center. Other dams are at red stars and yellow arrow. Thwake River runs through the center, at right scoop hole shows abundant water shallow in the sand.
